THE RUINS MIXED-USE DEVELOPMENT

Watertown, SD

CONSTRUCTION OBSERVATION REPORT

Project No. 24-020

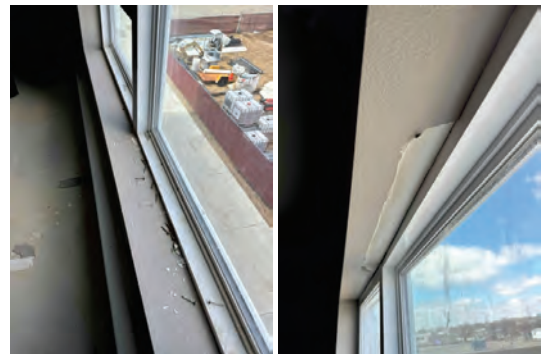
#454: Repair water damaged drywall at living room window

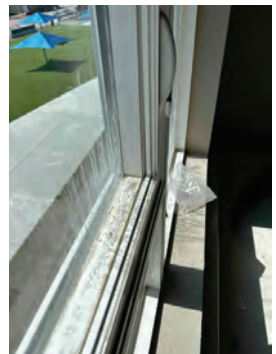
#410: Window operable frame is warped at bedroom

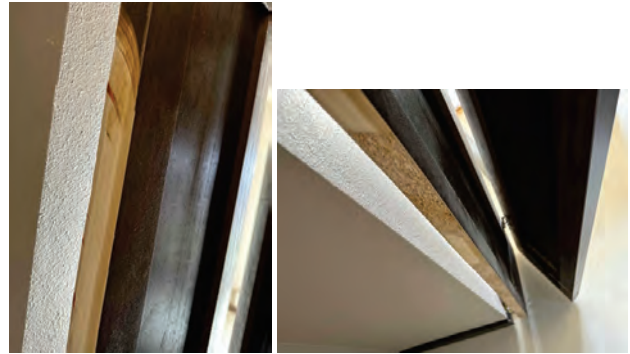
#411: Complete door hardware A-C: Gehrtz Construction Reports Page 193 of 410

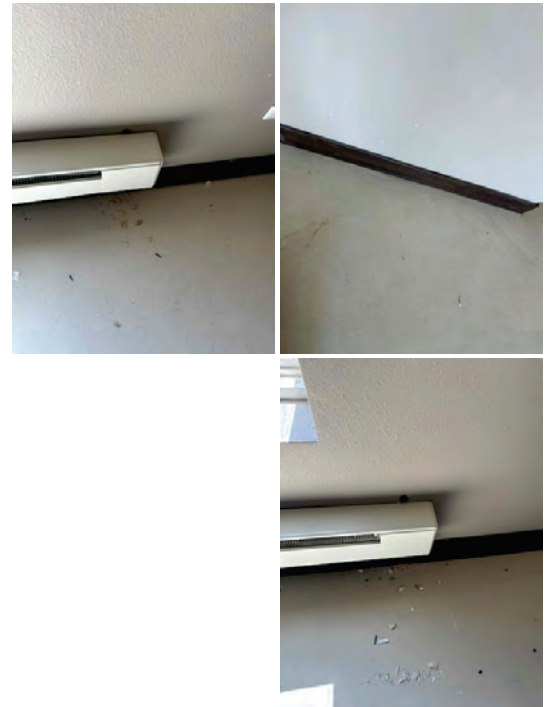
#412: Drywall patch

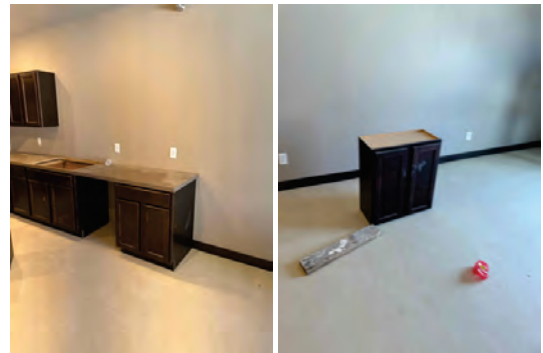
#430: Complete cabinets, countertops, and trim

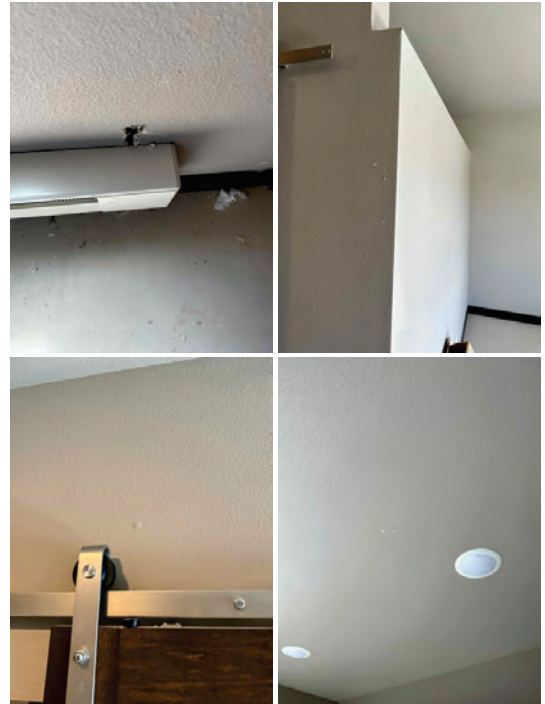
#392: Drywall patch

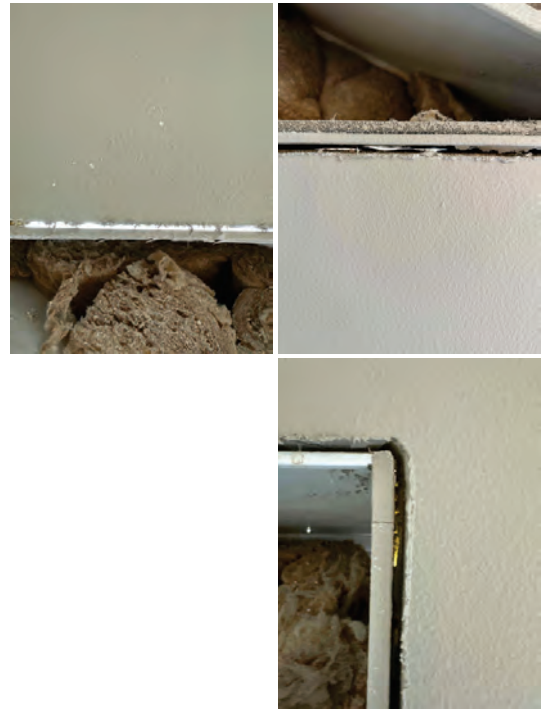
#416: Seal AC can

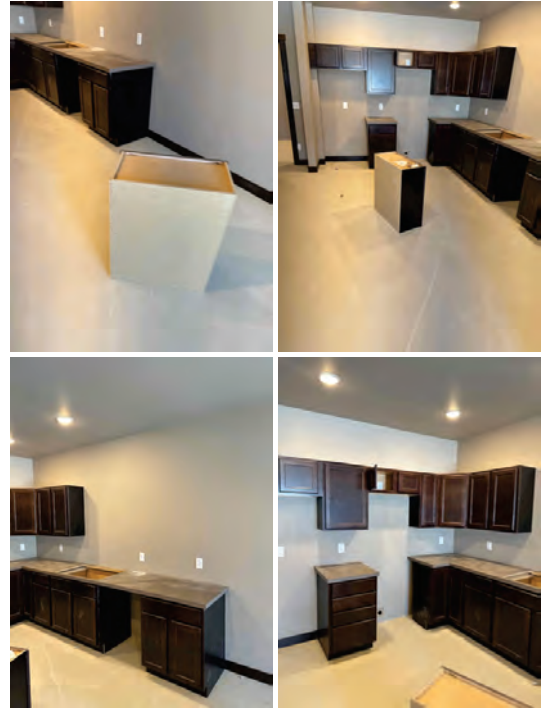
#417: Complete cabinets, countertops, and trim

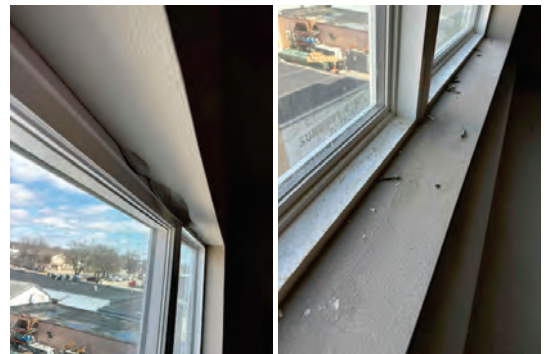
#421: Repair water damaged drywall at living room window

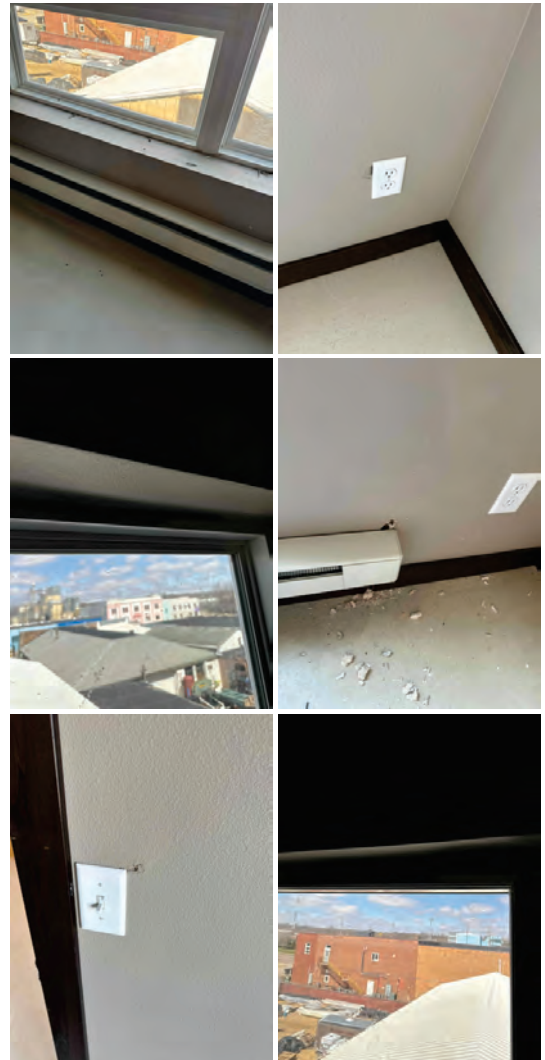
#423: Drywall patch

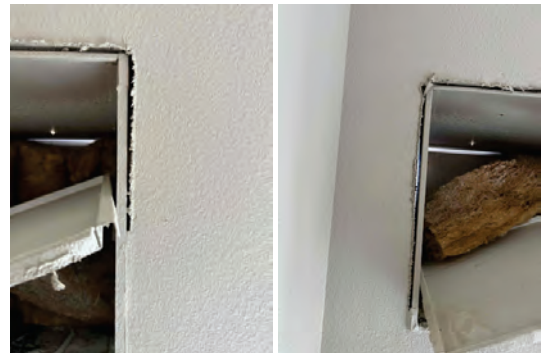
#327: Seal AC can

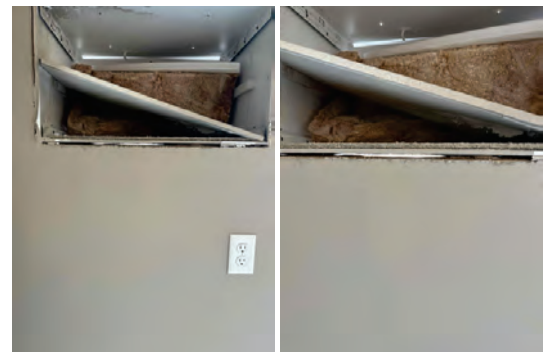
#395: Seal AC can

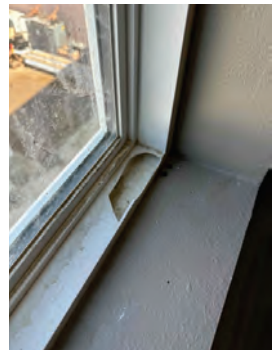
#400: Window frame broken in living room

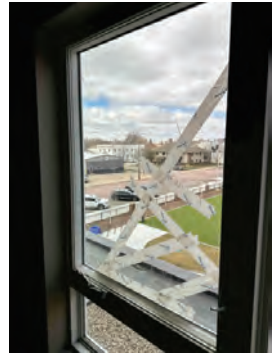
#302: Window Pane Broken in living room

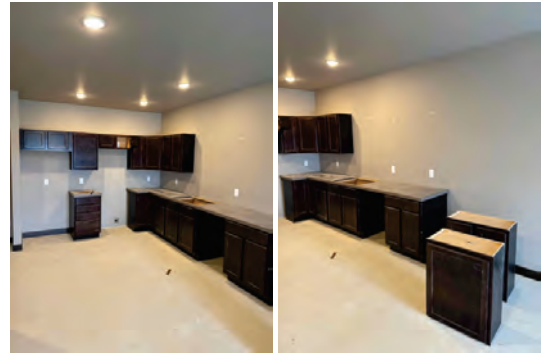
#305: Complete cabinets, countertops, and trim

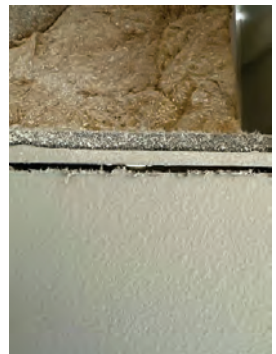
#286: Seal AC can

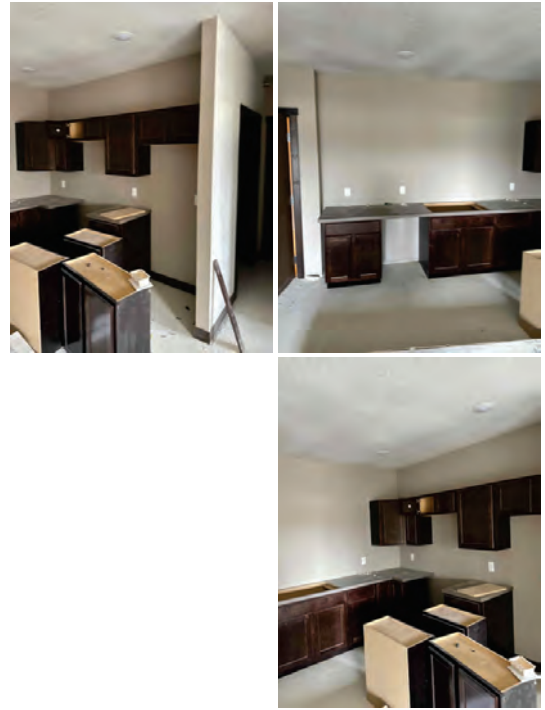
#359: Complete cabinets, countertops, and trim

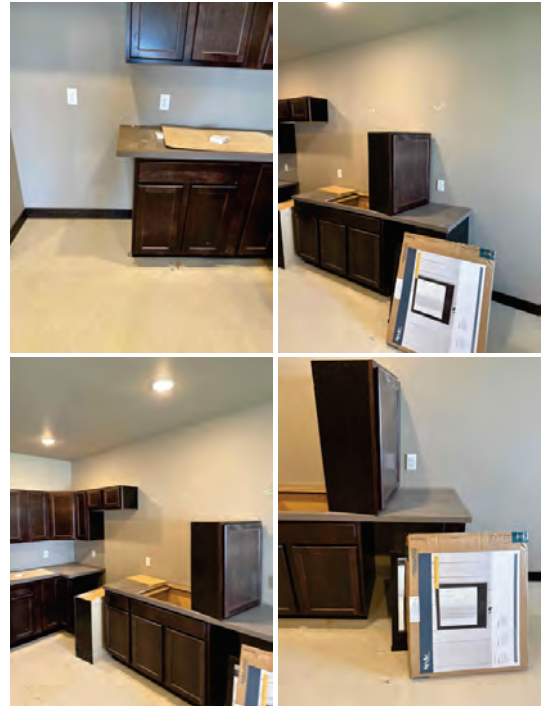
#263: Complete cabinets, countertops, and trim

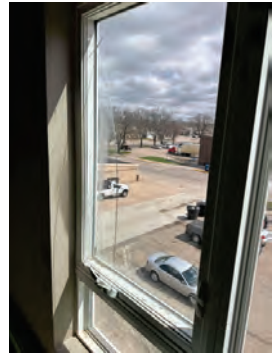
#348: Window Pane Broken in bedroom

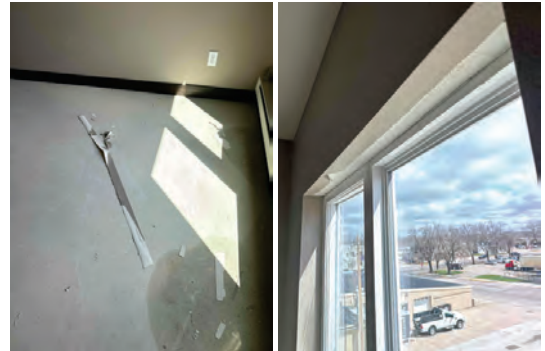
#349: Repair water damaged drywall at bedroom window

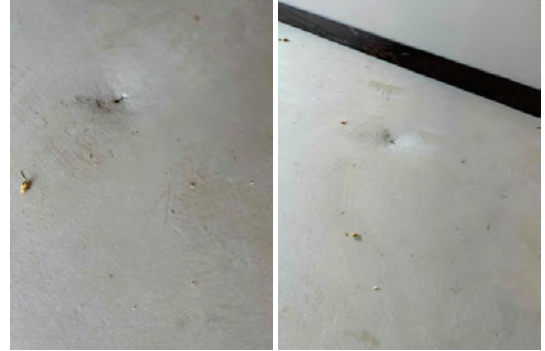
#352: Complete flooring

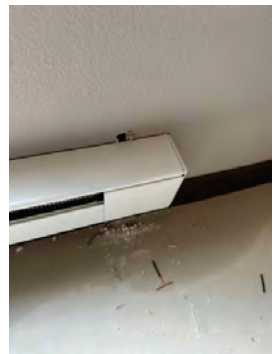
#353: Drywall patch

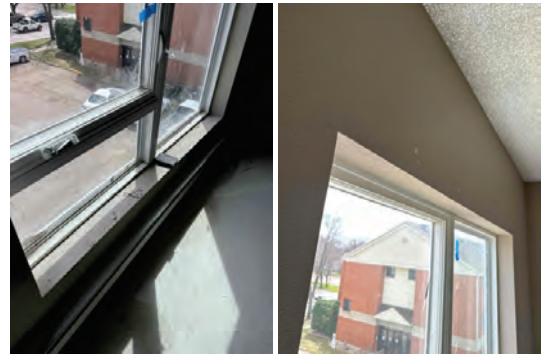
**#365: Repair water damaged drywall at living room window**

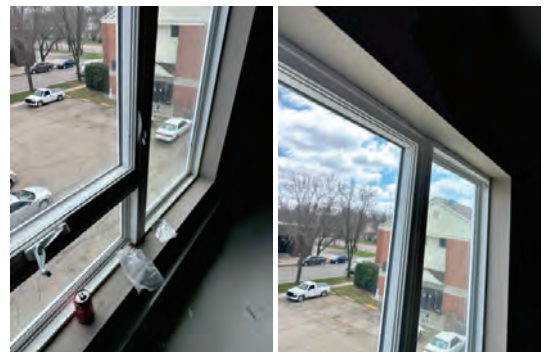
**#368: Repair water damaged drywall at bedroom window**

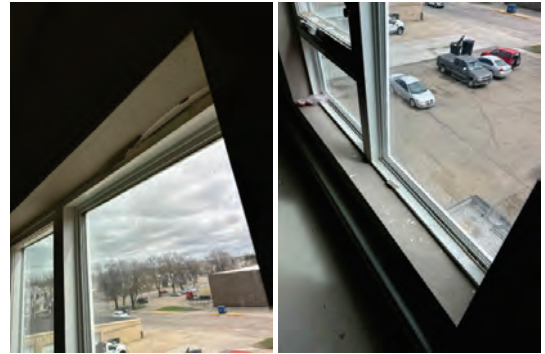
#337: Repair water damaged drywall at bedroom window

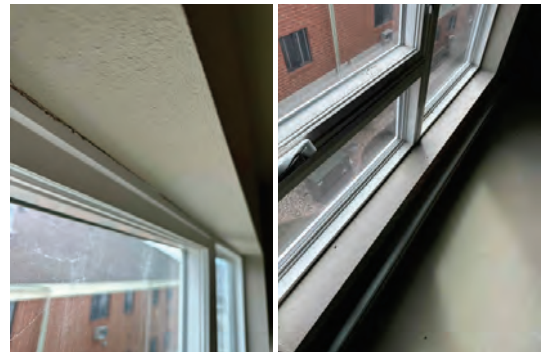
#341: Repair water damaged drywall at living room window

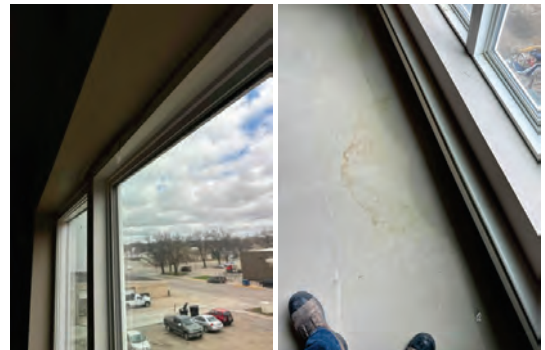
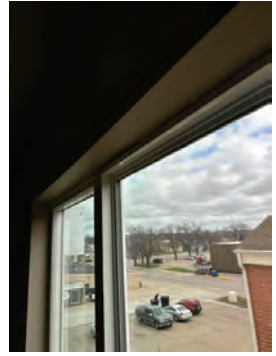
#315: Repair water damaged drywall at living room window

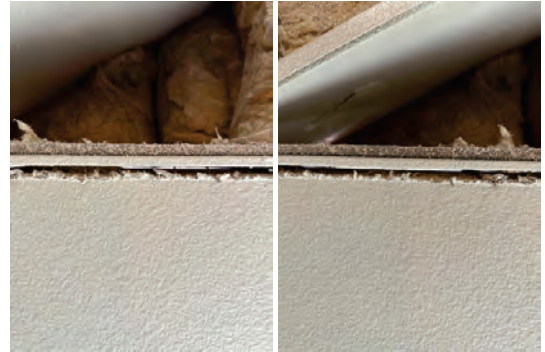
#316: Seal AC can

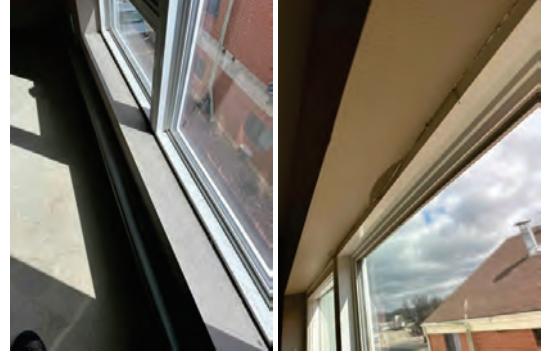
#294: Repair water damaged drywall at living room window

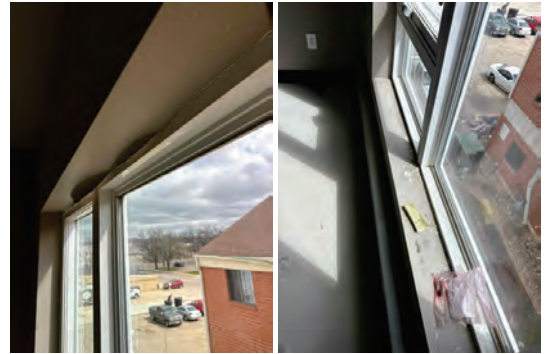
#296: Repair water damaged drywall at bedroom window

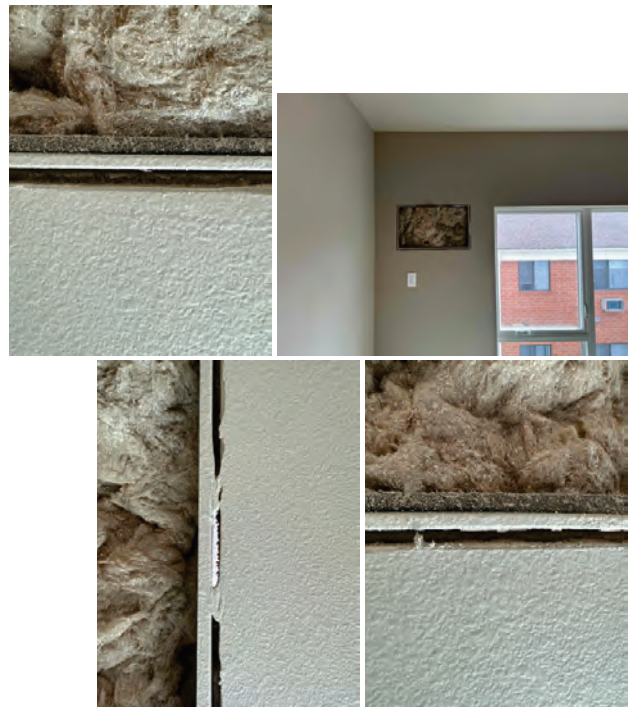
#297: Seal AC can

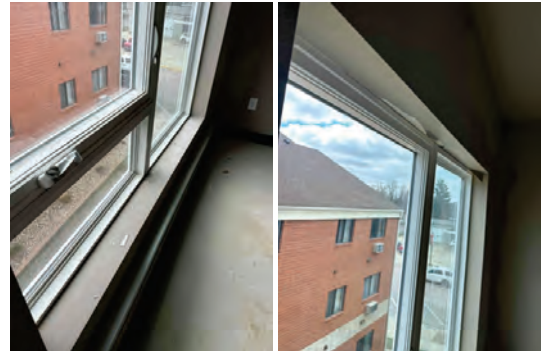
#274: Repair water damaged drywall at living room window

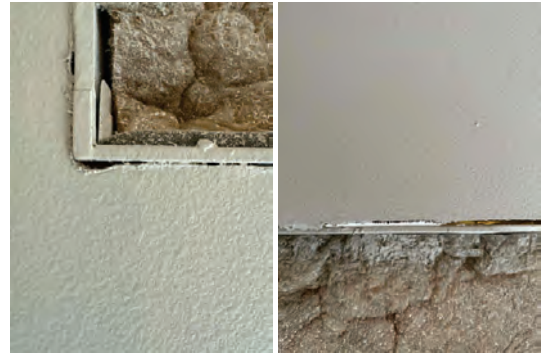
#275: Seal AC can

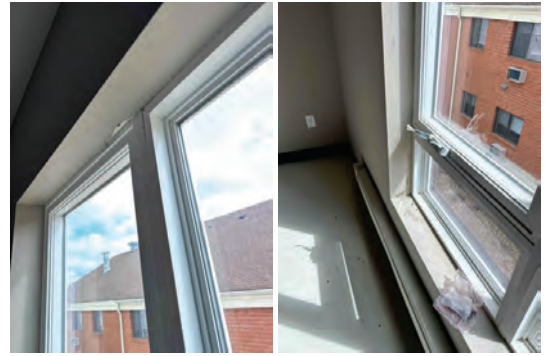
Type: Location:
3rd Floor>Unit 325

#253: Repair water damaged drywall at bedroom window

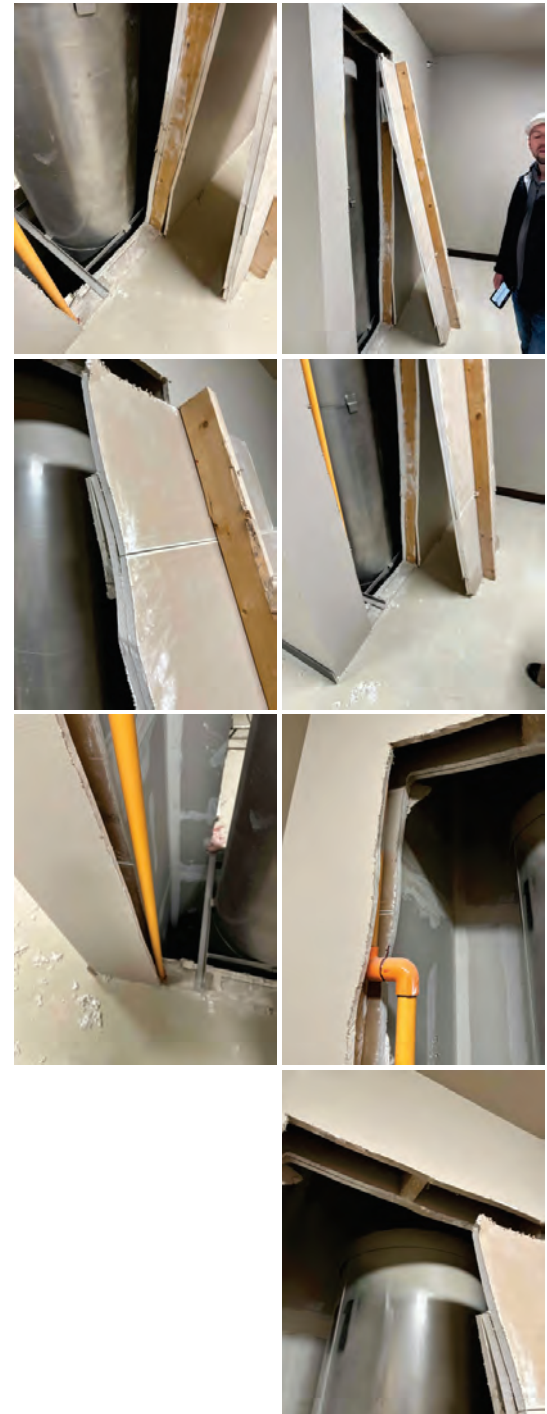
Wall for trash chute does not meet 2-hour

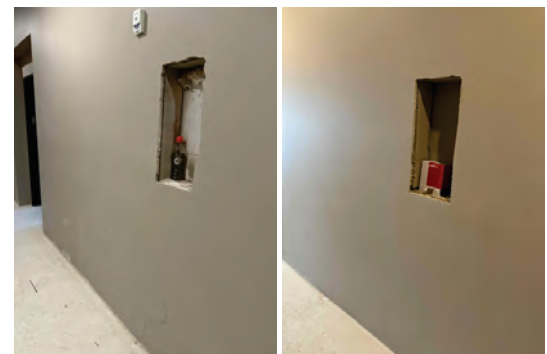
Type:	Location: 4th Floor Hallway
Date Created: 04/17/2024	Due Date: 04/20/2024
Priority:	Status: Initiated

#219: Fire Extinguisher Cabinet Missing - RO too high

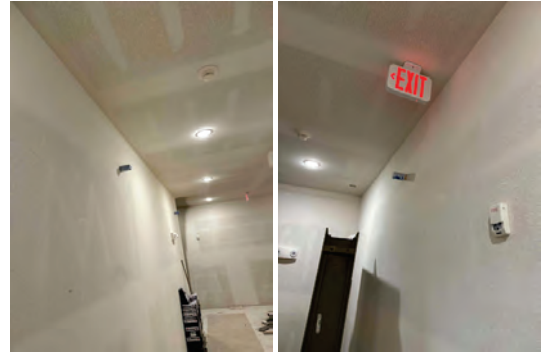
Type:	Location: 4th Floor Hallway
Date Created: 04/17/2024	Due Date: 04/20/2024
Priority:	Status: Initiated

#220: Sprinkler Escutcheons Missing

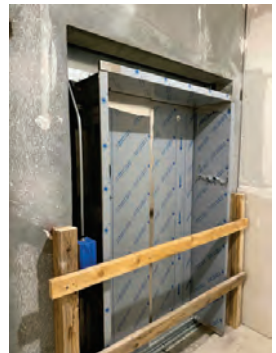
Type:	Location: 4th Floor Hallway
Date Created: 04/17/2024	Due Date: 04/20/2024
Priority:	Status: Initiated

#221: Masonry infill at elevator frame - needs 2HR rating

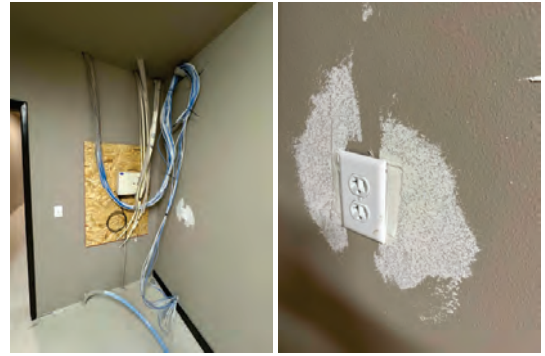
Type: Location:
4th Floor>Mech/Jan't

#102: Electrical incomplete

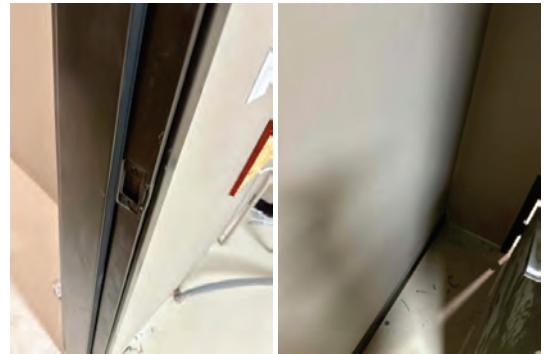
Type: Location:
4th Floor>Mech/Jan't

**#103: Complete door hardware**

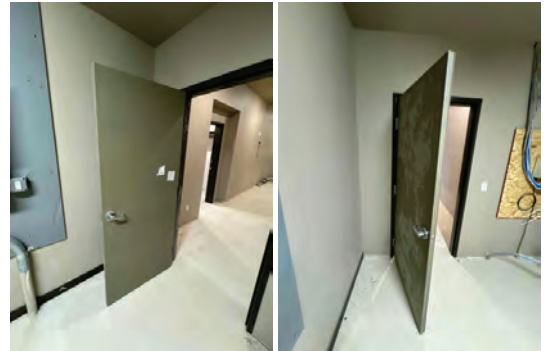
Type:	Location: 4th Floor>Mech/Jan't
Date Created: 04/17/2024	Due Date: 04/20/2024
Priority:	Status: Initiated

#106: Paint Door

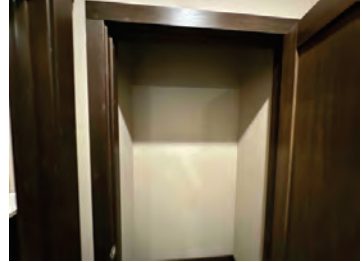
Type: Location:
4th Floor>Unit 400

#5: Shelving Missing

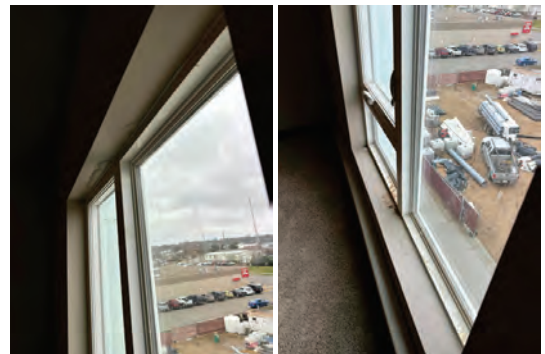
#42: Repair water damaged drywall at bedroom window

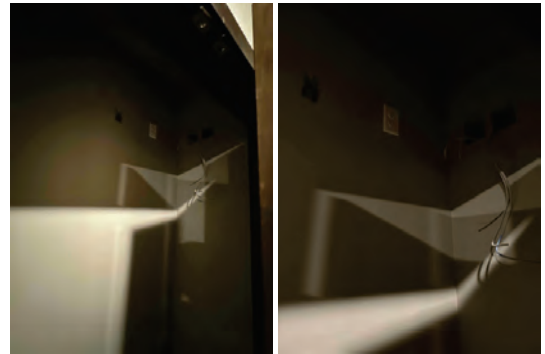
#44: Electrical incomplete

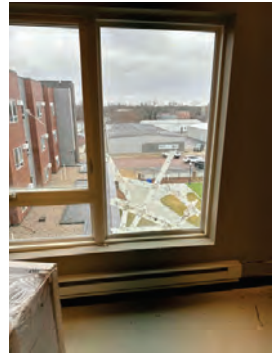
#78: Window Pane Broken in living room

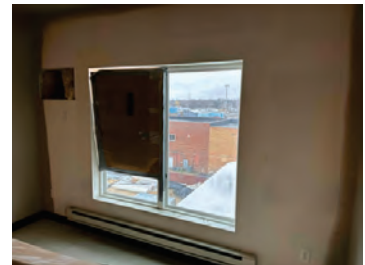
#46: Finish paint & paint touch ups

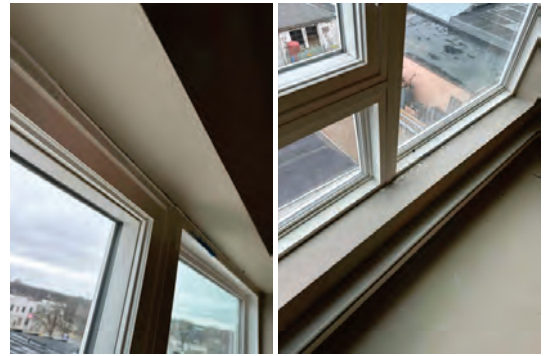
#68: Repair water damaged drywall at living room window

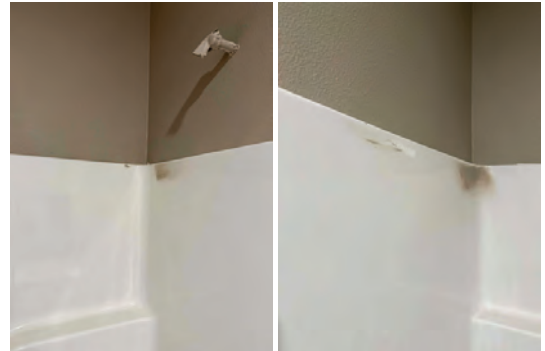
#71: Clean up paint

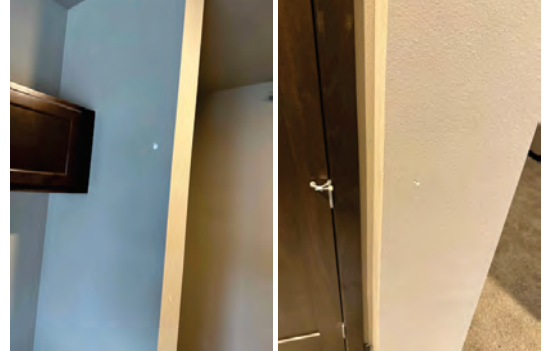
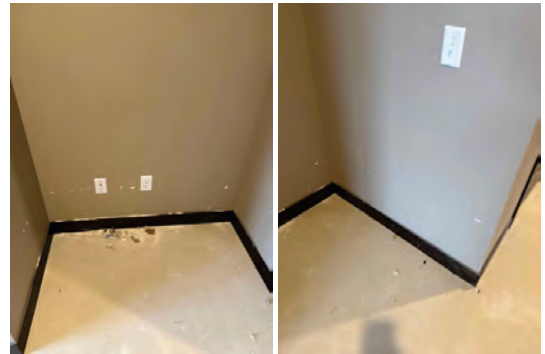
#93: Drywall patch

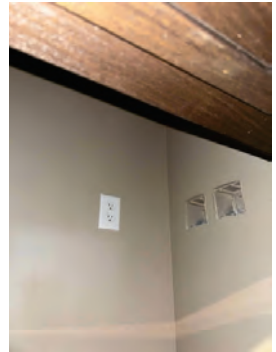
#187: Electrical incomplete

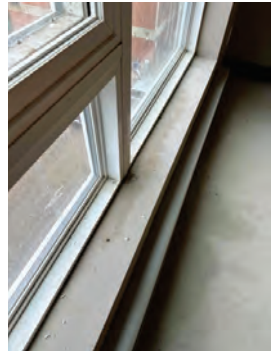
#111: Complete caulking at countertops & windows

Type: Location:
4th Floor>Unit 413

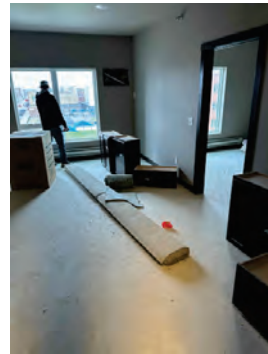
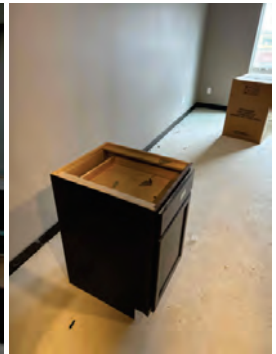
#202: Complete caulking at countertops & windows

Type:	Location: 4th Floor>Unit 414
Date Created: 04/17/2024	Due Date: 04/20/2024
Priority:	Status: Initiated

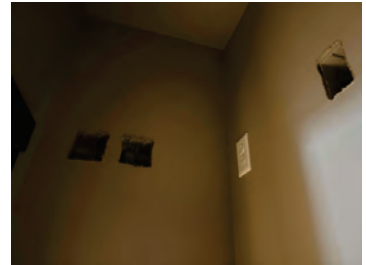
#206: Drywall patch

Type:	Location: 4th Floor>Unit 414
Date Created: 04/17/2024	Due Date: 04/20/2024
Priority:	Status: Initiated

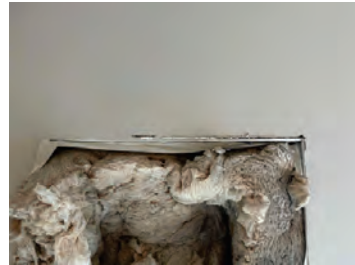
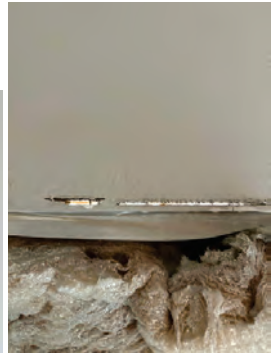
#137: Seal AC can

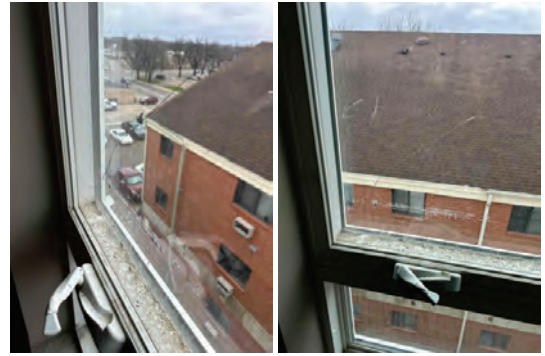
#174: Window Pane Broken in living room

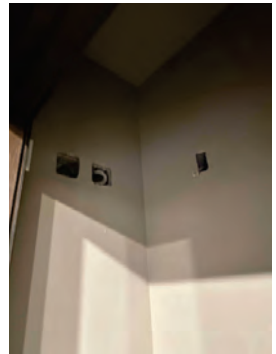
**#175: Electrical incomplete**

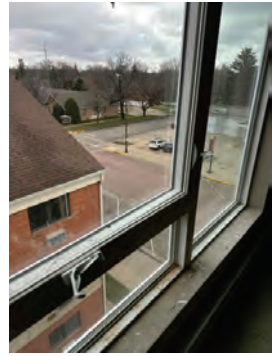
#209: Window latch inoperable in living room

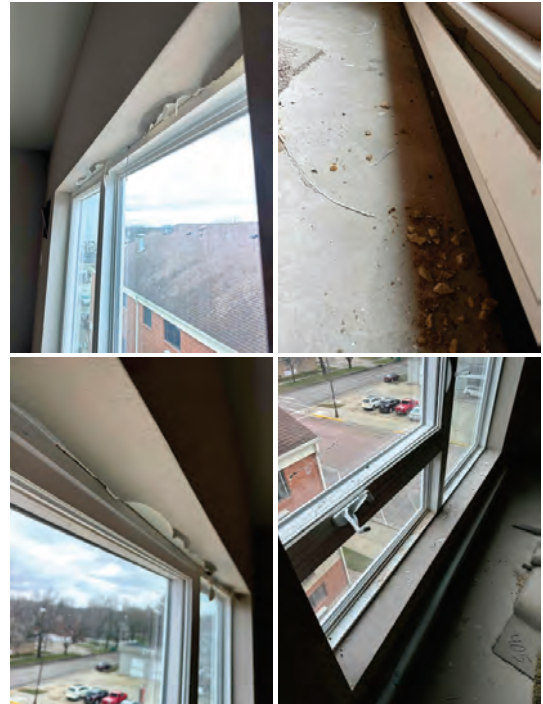
#213: Repair water damaged drywall at living room window

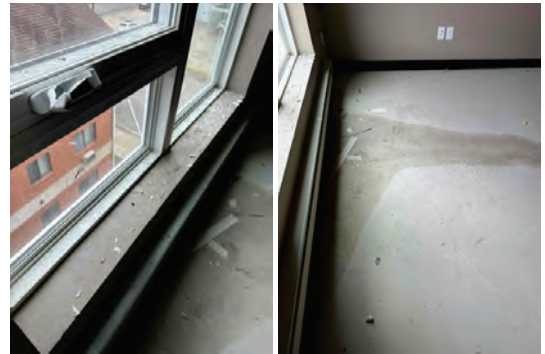
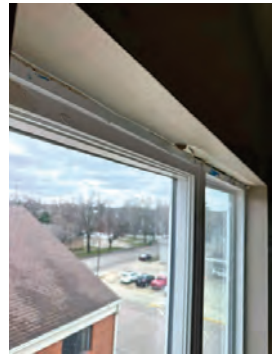
**#215: Repair water damaged drywall at bedroom window**

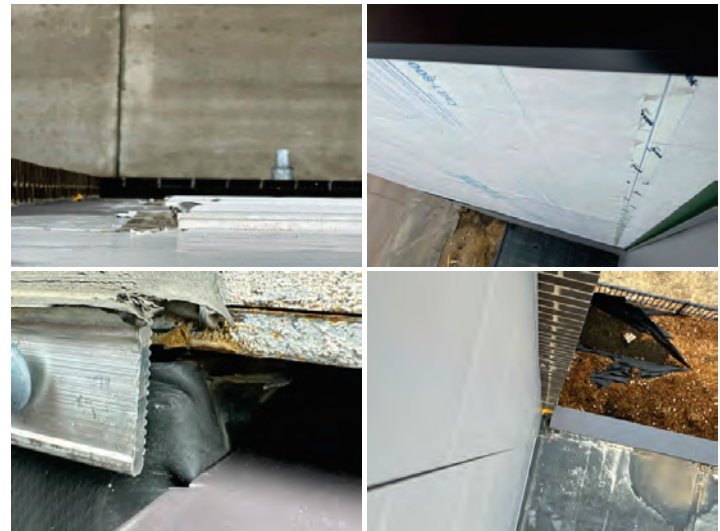
#225: Roof items

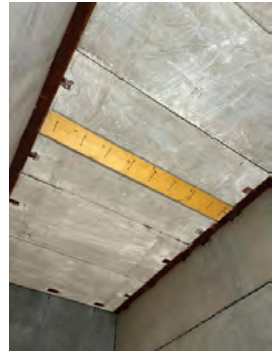
#229: Remove board

Type:	Location: West Stairwell
Date Created: 04/17/2024	Due Date: 04/20/2024
Priority:	Status: Initiated

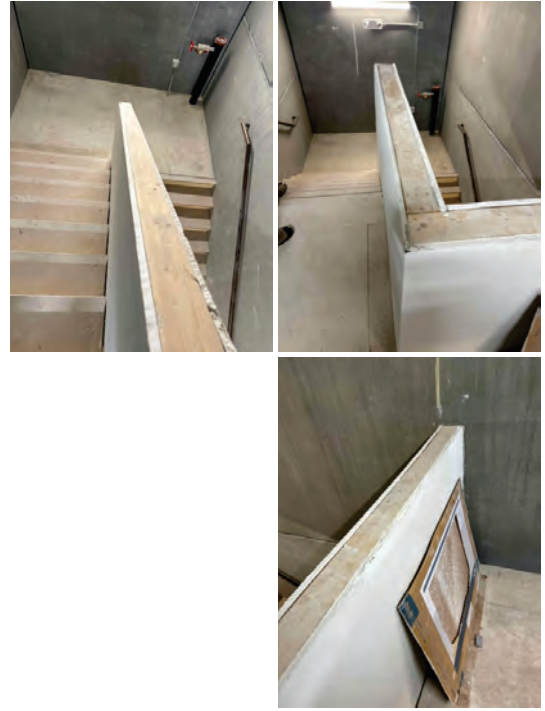
#230: Finish top cap

Type:	Location: West Stairwell
Date Created: 04/17/2024	Due Date: 04/20/2024
Priority:	Status: Initiated

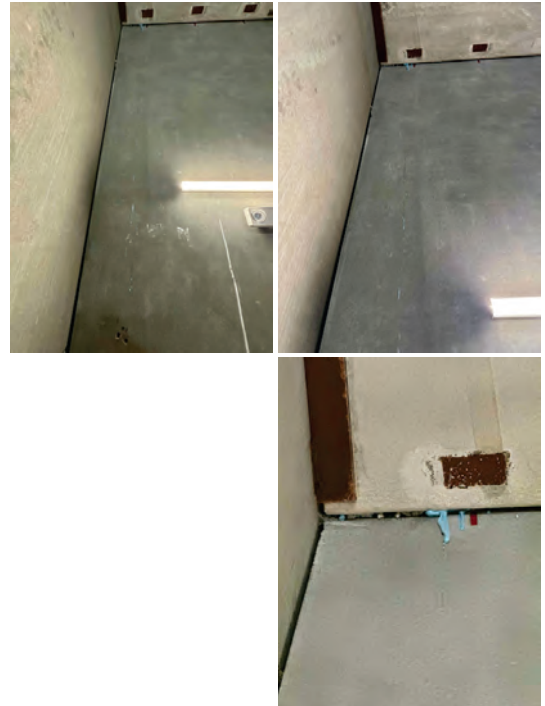
#231: Remove adhesive

Type:	Location: West Stairwell
Date Created: 04/17/2024	Due Date: 04/20/2024
Priority:	Status: Initiated

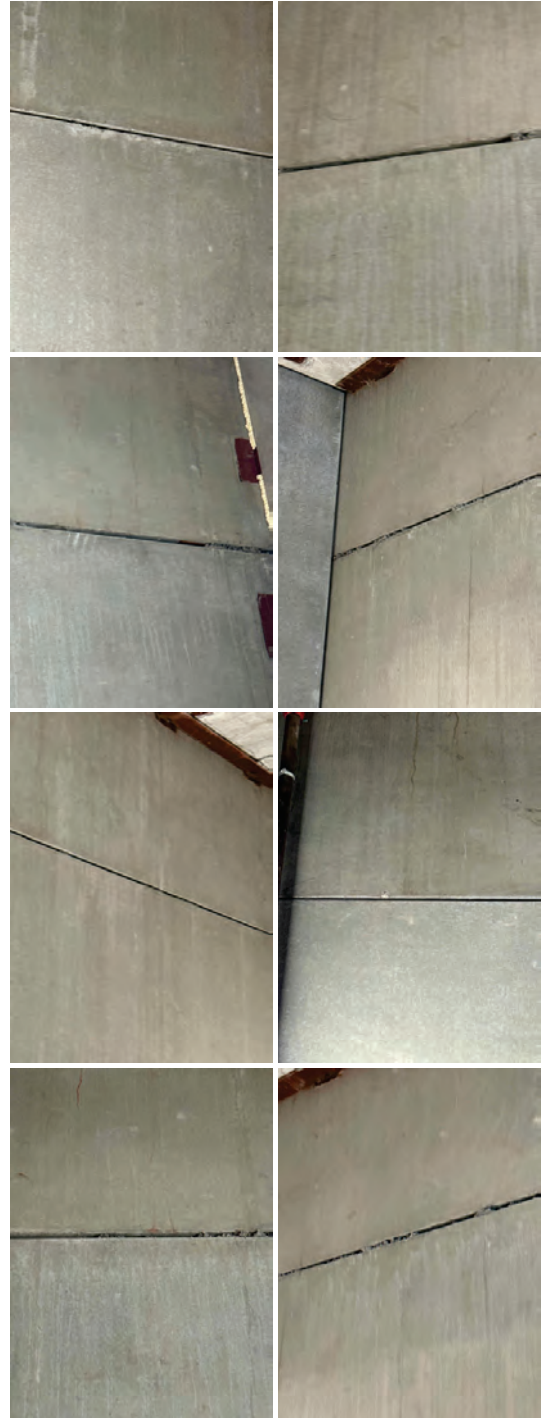
#232: Complete grout at precast panels

Type:	Location: West Stairwell
Date Created: 04/17/2024	Due Date: 04/20/2024
Priority:	Status:

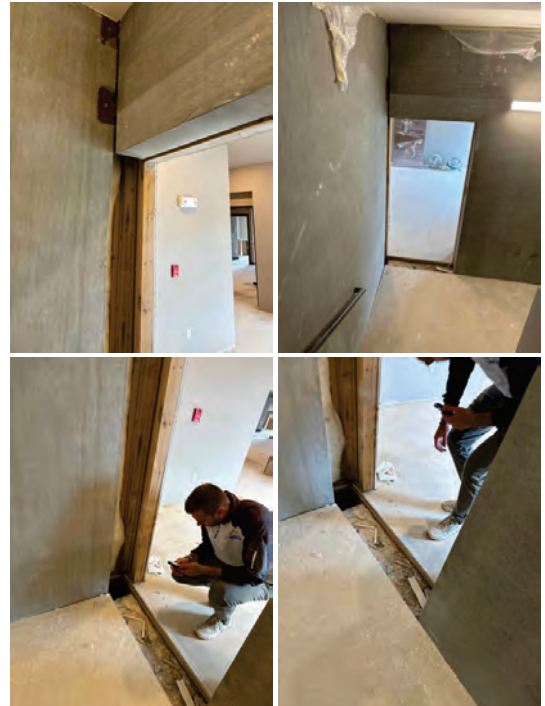
#234: Complete door hardware

Type: Location:
West Stairwell

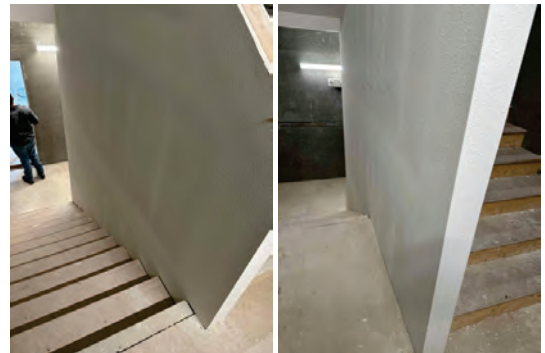
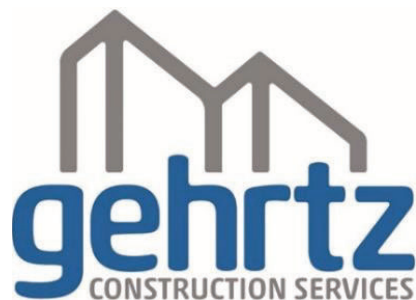
#235: Railing missing at center stairwell wal

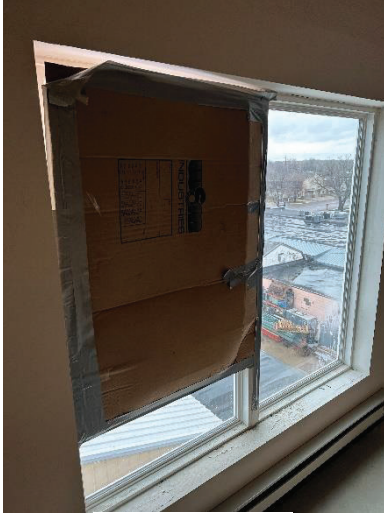
4th Floor Unit,
April 17, 2024

GCS observed no significant advancement in work on the project since the first site inspection on April 17th, 2024. Please reference the previous site inspection report for all details pertaining to work remaining. In addition, areas that were noted showing signs of water penetration and damage in the previous report appeared to have deteriorated further from the time of original inspection on April 17th, 2024. The following page contains photos showing this deterioration.
